3100 Loyola Drive, Davis | [www.korematsu.djUSD.net](http://www.korematsu.djUSD.net)

## FACILITY CONDITION ASSESSMENT KOREMATSU ELEMENTARY

**FACILITY CONDITION ASSESSMENT  
KOREMATSU ELEMENTARY**

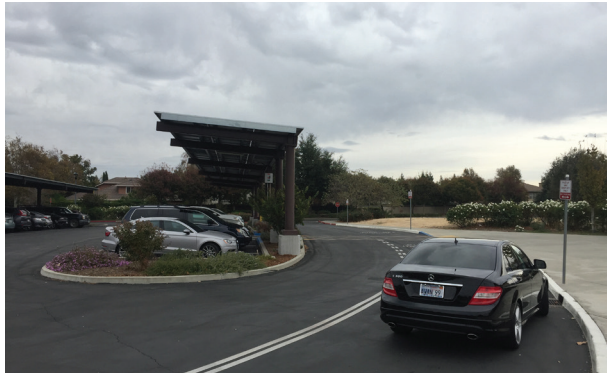
Drop-Off Lane

- Although one of the largest parking lots in the district, the entry/exit and drop off locations seem to not be clear enough to provide adequate safety for children.

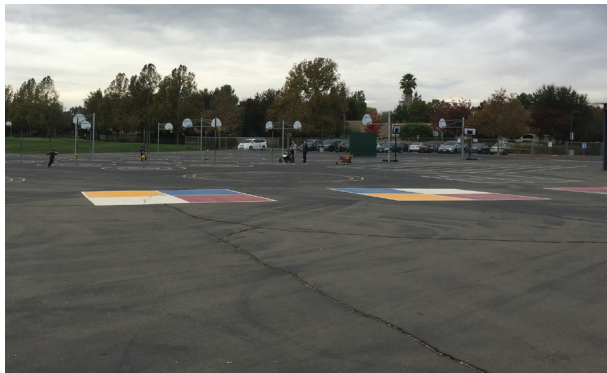
- AC paving at hardcourts has deep cracks that need repairing. Hardcourts will need to be resurfaced and painted.

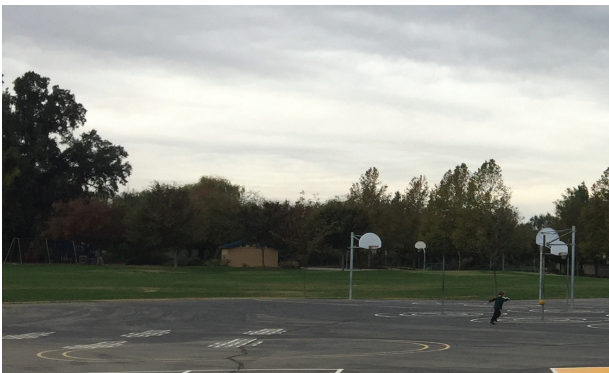
Playfields / Athletics

- Campus could use more storage for athletic equipment.

- Playfields are very open and allow wanderers and members of the community to enter and cross freely. Principal would like to create a perimeter with “natural fencing” to help keep campus secure and unwelcome visitors out.
