FACILITY CONDITION ASSESSMENT CESAR CHAVEZ ELEMENTARY

**EXISTING CAMPUS PLAN
 CESAR CHAVEZ ELEMENTARY**

**PROPOSED CAMPUS MASTER PLAN
 CESAR CHAVEZ ELEMENTARY**

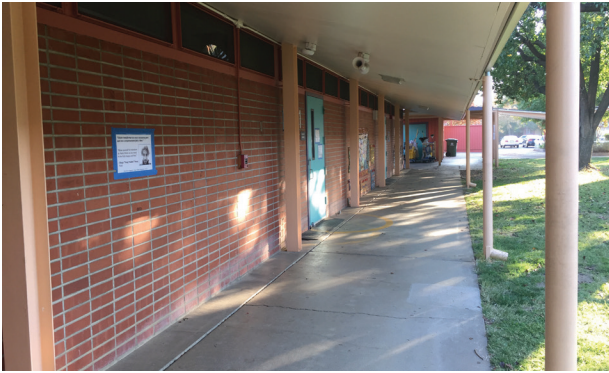
Covered Walkway

- Walkway awnings appear to be in good condition.

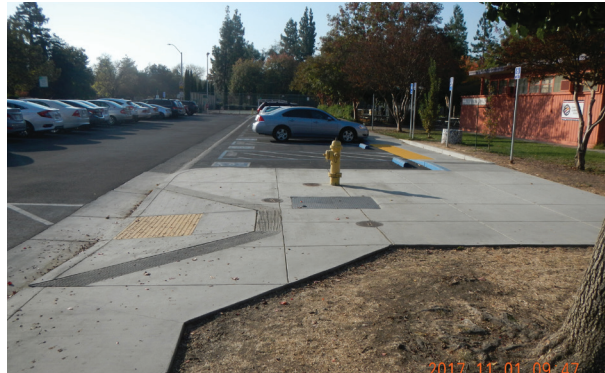
Drop-Off Lane

- Parking occurs in a small lot at the street frontage, with a single point of ingress/egress.
- A portion of this lot is dedicated to bike parking.
- Additional parking is desired by the site.
- Drop-off lane is curbside along Anderson Road; no formal drop-off lane is provided.

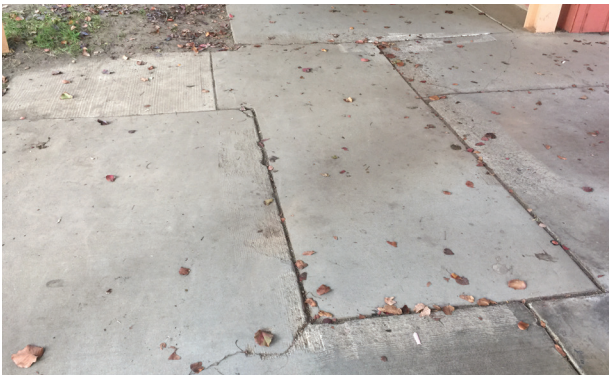
Concrete Paving

- Concrete paving is patchy between classroom wings.
- Concrete paving is new at the recently-added classrooms and Kindergarten wing.
- Paving adjacent the original school buildings shows patching and repairs over time.

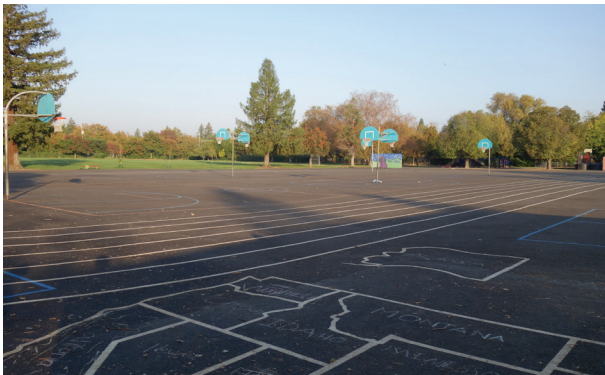
Hardcourts

- AC paving at the hardcourts and between classroom wings (where occurs) was resurfaced in 2017 and is in good condition.
- AC paving at the parking lot is in good condition.

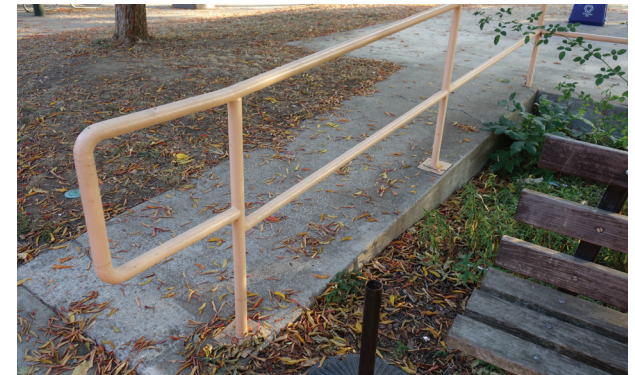
Ramp

- The ramp at the rear of Admin, leading to the Kindergarten yard is in new condition.

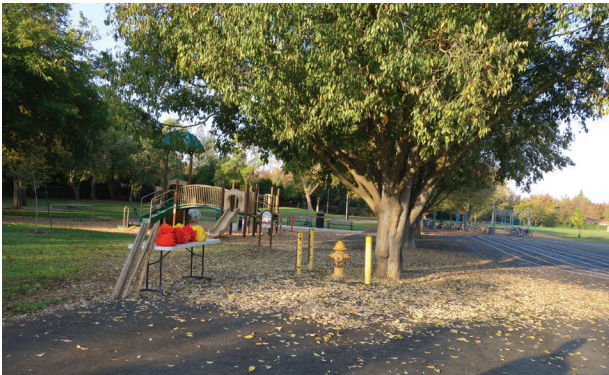
Playfields / Athletics

- Playfield is uneven.

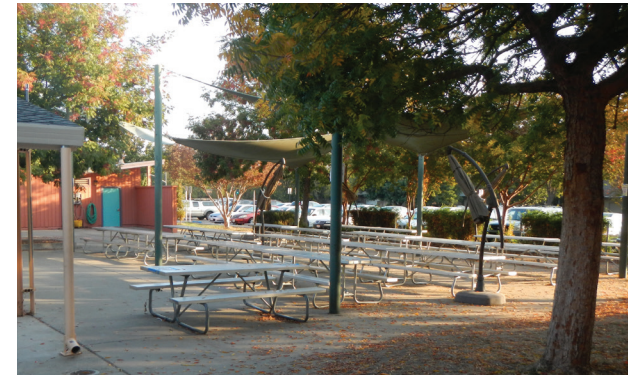
Shade Structure

- Shade sails at student dining are in poor condition and have been supplemented with collapsible umbrellas.
- Shade is desired at the new classroom / Kindergarten wing.

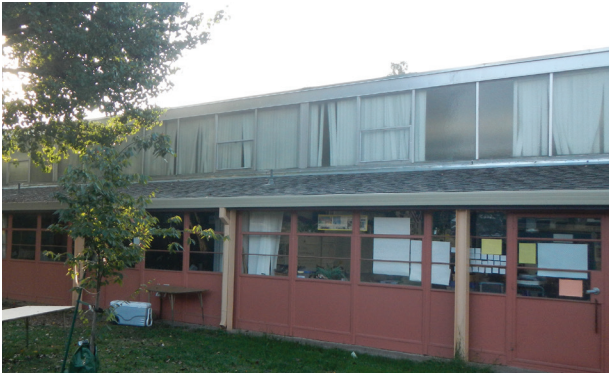
- Windows are non-operable and single-pane at all original buildings. Some clerestory windows at the original buildings are operable. All windows have vertical blinds.
- MPR has a linear skylight that runs the length of the roof and has operable slats for shade.
- The new classroom / Kindergarten wing has dual-pane, non-operable windows.

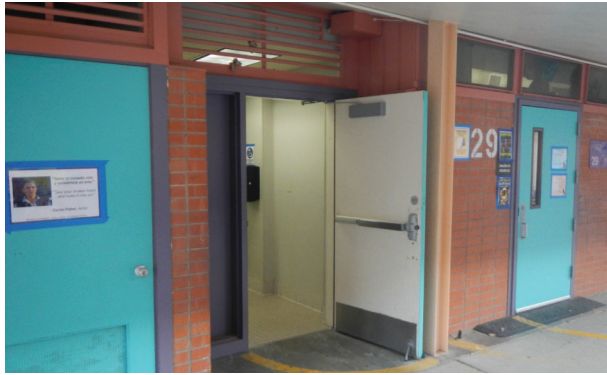
Exterior Door Hardware

- Doors, frames, and hardware appear to be in good condition.

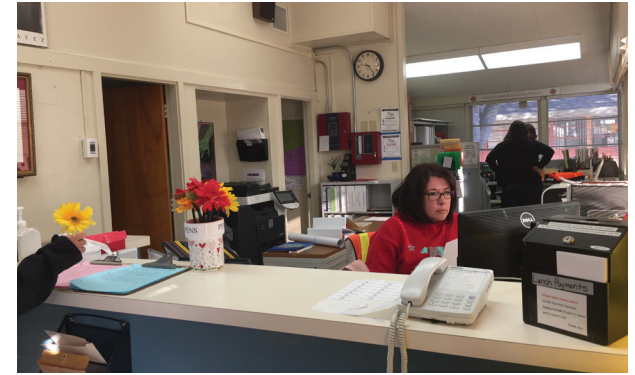
Administration Office

- Administration office is not insulated.

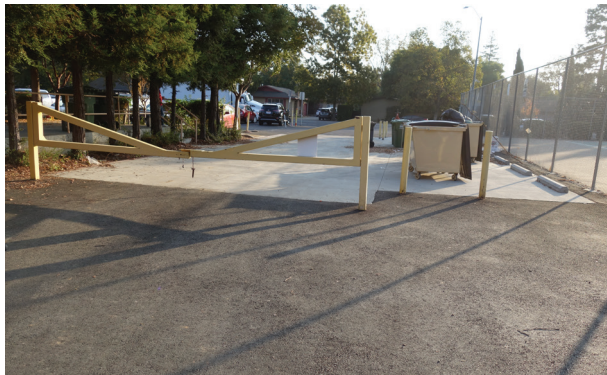
Fencing / Gates

- Fencing at the Kindergarten play yard is full-height and in good condition. A new gate with panic hardware has been installed.

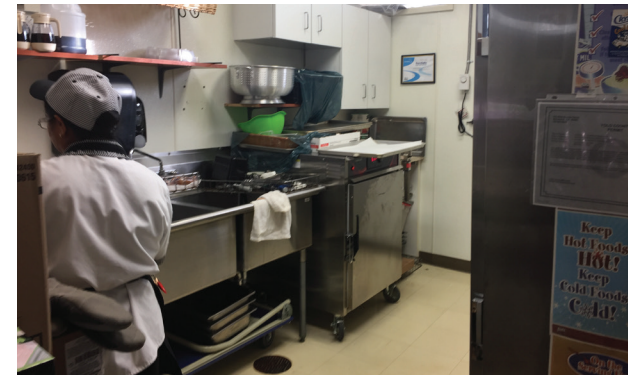
Food Service

- Small heat/serve kitchen (approximately 10' by 16').
- Dining always occurs outside.
