## SITE DATA

Year Built: 1957

**FACILITY CONDITION ASSESSMENT  
NORTH DAVIS ELEMENTARY**

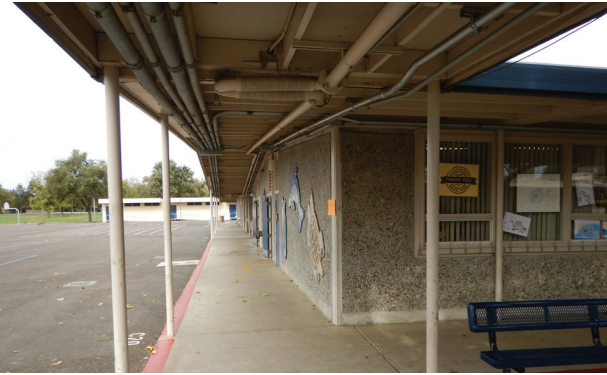
Covered Walkway

- Covered walkway structures are in good condition, minor patching.

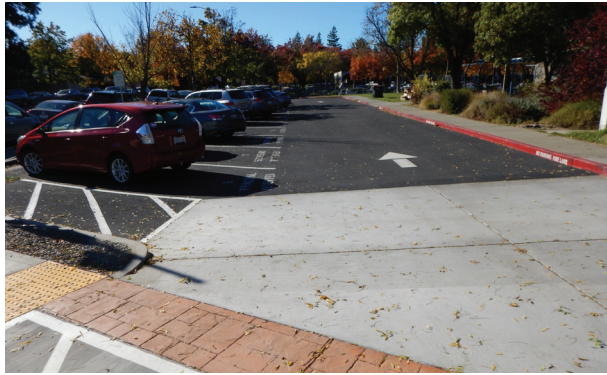
Drop-Off Lane

- Current capacity is not enough to accommodate campus staff load (about 58).
- There is no identified drop off area, just fire lane.

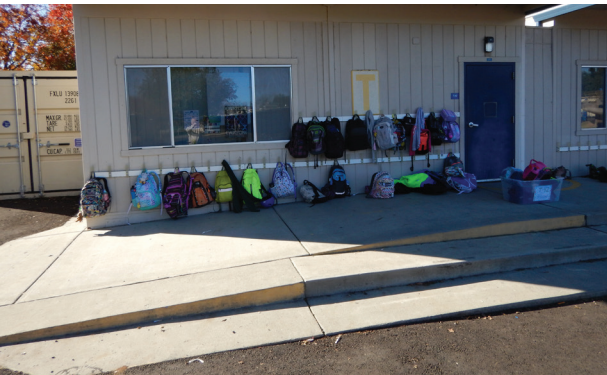
Concrete Paving

- In general, the concrete paving is in good condition. Minor cracks observed, normal wear and tear. Several areas have uneven surface concrete joints with the AC / concrete paving which need to be repaired to mitigate tripping hazards.

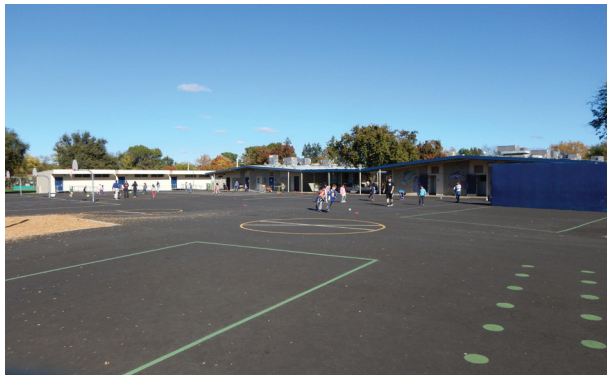
Hardcourts

- Bounce walls surface material are damaged, need repair.

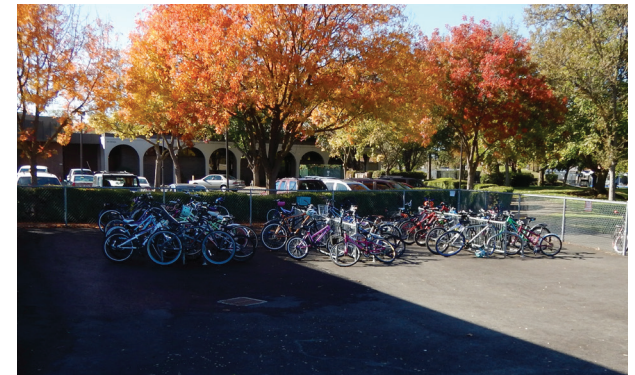
Bike Parking

- In general, in good condition in the two locations on campus, normal wear and tear.

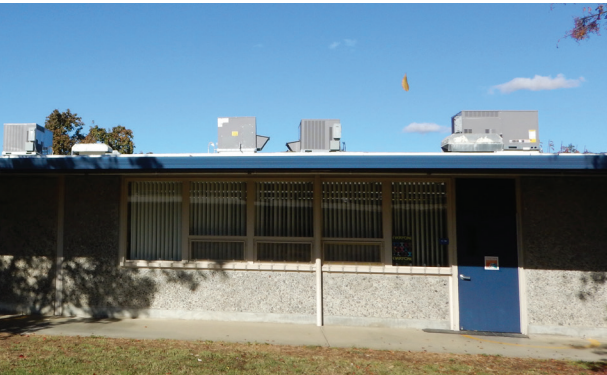
Windows

- In general, in good condition throughout campus.
- Buildings will benefit from insulated double pane windows, most of them are single pane.

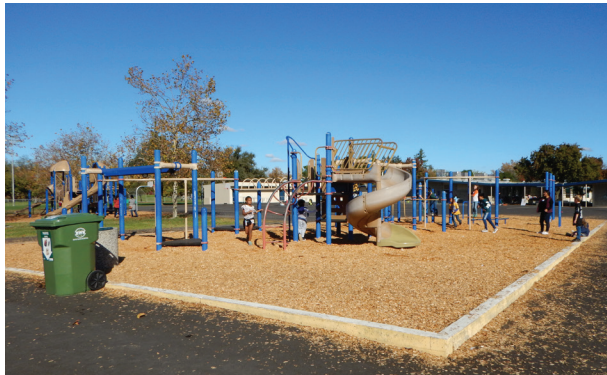
Play Structure

- No issues were observed or reported.

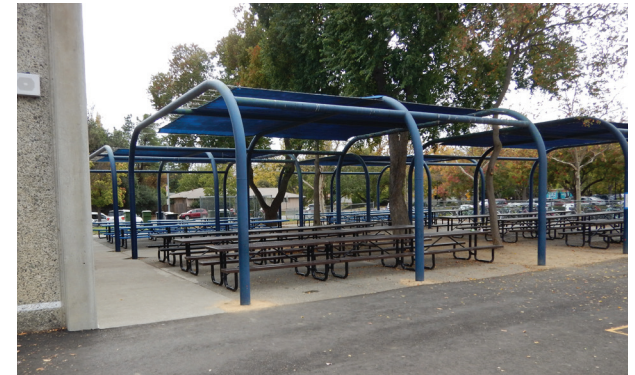
Shade Structure

- In general, in good condition, normal wear and tear.

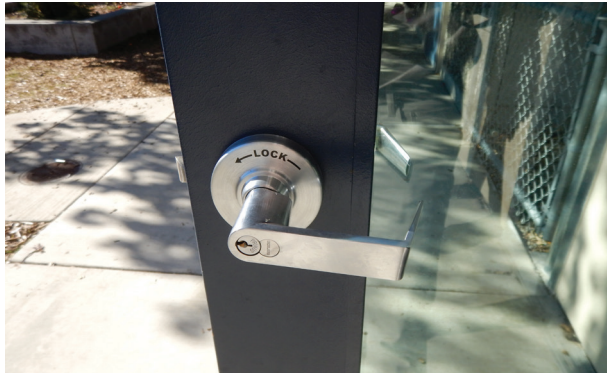
Exterior Door Hardware

- In general, in good condition through campus, normal wear and tear.
- Classroom locks to be verified for compliance with classroom security locks by DSA.

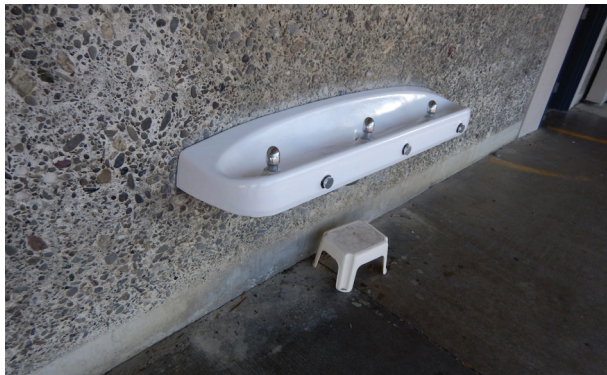
Drinking Fountain

- Existing drinking fountains to be replaced with hi-low units meeting accessibility. Install protection rails on each side.

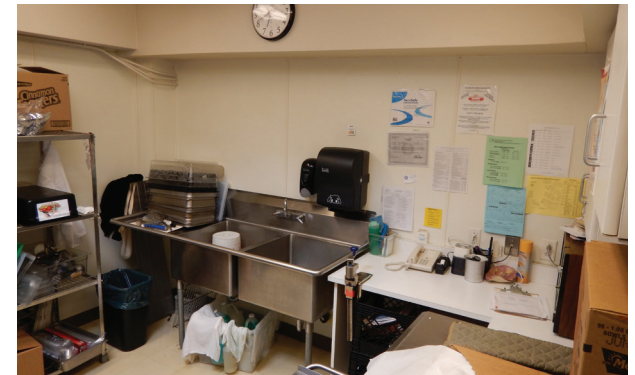
Food Service

- Very small area for food preparation, no formal space for serving food.
- Inadequate equipment required capacity of the kitchen.
