FACILITY CONDITION ASSESSMENT EMERSON JUNIOR HIGH

**EXISTING CAMPUS PLAN
 EMERSON JUNIOR HIGH - OVERALL**

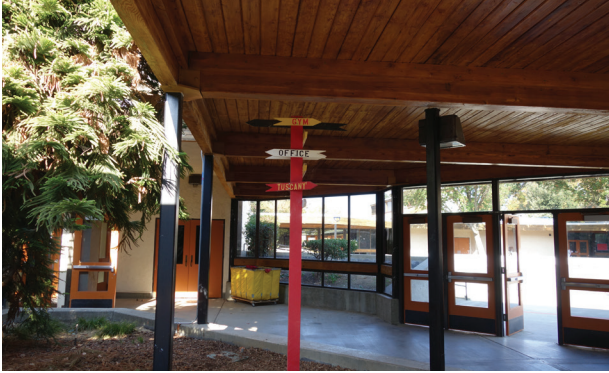
Covered Walkway

- Walkway awnings are in good condition.

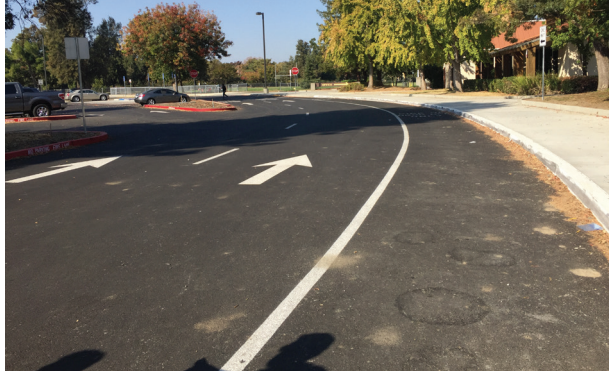
Drop-Off Lane

- Parking is sufficient with a dedicated drop-off lane separate from parking drive aisles.

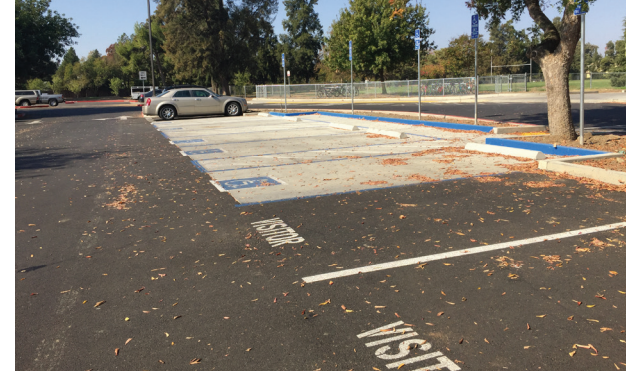
Parking

- AC paving at the parking lot was resurfaced in 2017 and is in good condition.
- AC paving at the hardcourts is in poor condition and needs to be resurfaced and striped.
- AC paving at the Lunch Courtyard needs to be resurfaced.

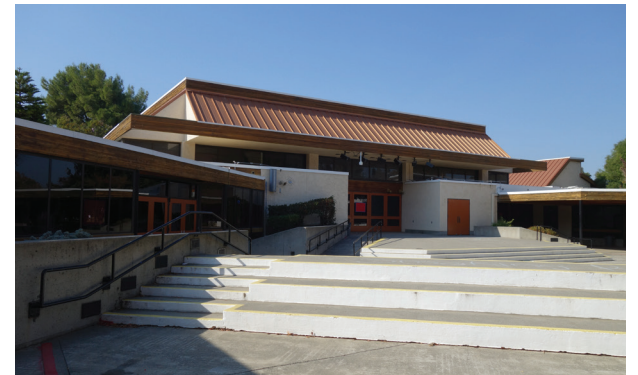
Ramps / Stairs

- The concrete stairs and ramps at the Outdoor Commons are in good condition.

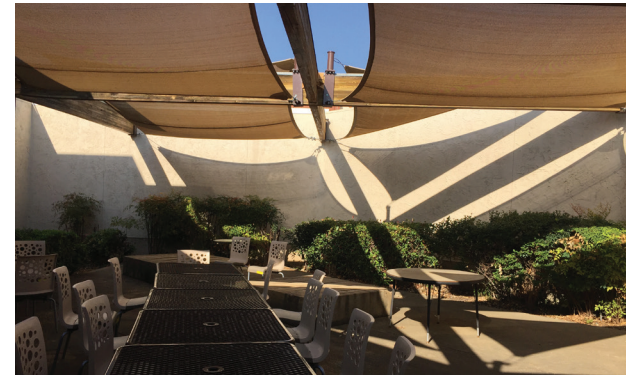
Library Shaded Patio

- Shade is desired at the Lunch Courtyard and the Arts Courtyard.
- Shade sails at the Library Courtyard are in good condition.

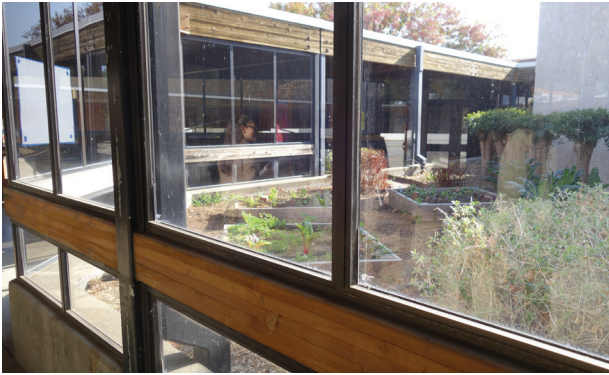
- Windows are single-pane. Wire mesh glazing is used in the music practice rooms and coaches' office of the locker rooms.

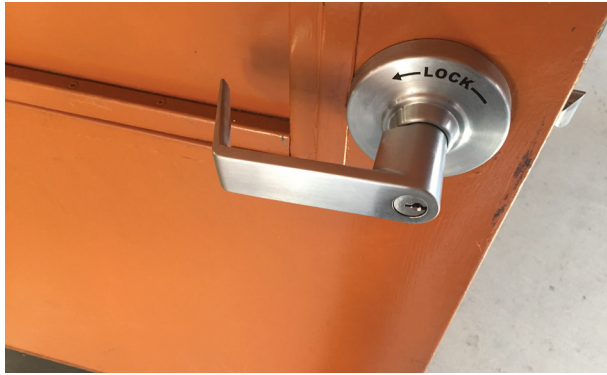
Exterior Door Hardware

- Exterior doors, frames, and hardware are in good condition.

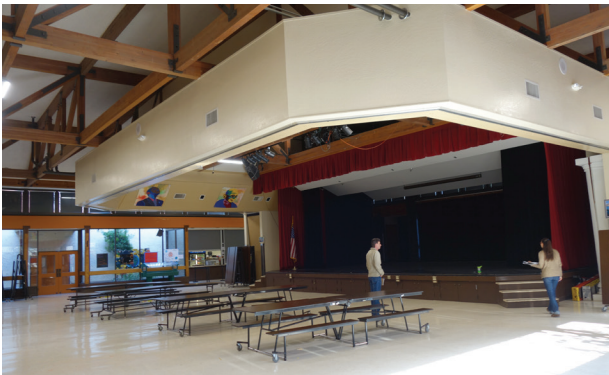
- All new HVAC and Control systems are needed.
- Library does not have air conditioning.
- Wood shop has new exhaust system.

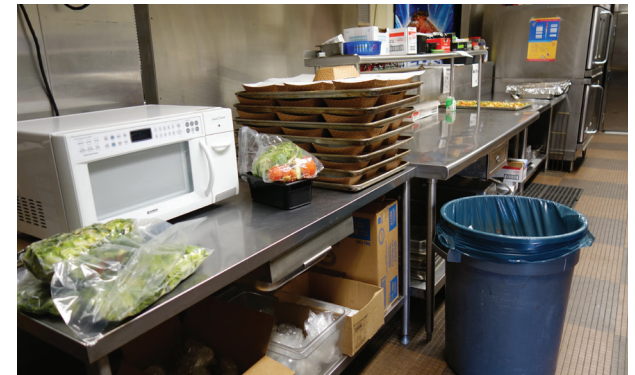
Food Service

- The heat/serve kitchen is in good condition.

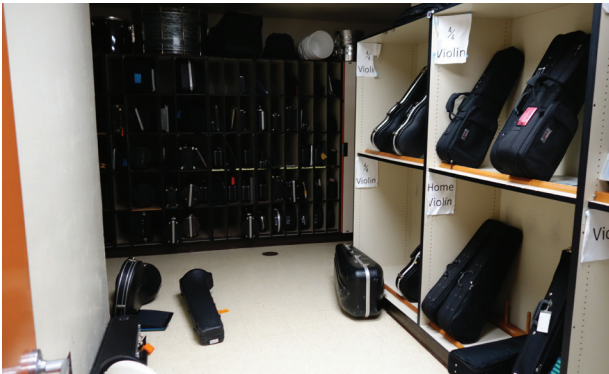
Music Room Storage

- Wayfinding is difficult, and hallways become congested between classes.
- Courtyards are mainly used as storage. Art courtyard houses two kilns and is always used.
- Science rooms have a lab setup with no separate area for lecture.
- The stage at the Indoor Commons is the largest in the District and is shared for community use.
- The Tech Lab houses math as well as the computer robotics program.
- The practice rooms in the Music room are used for storage.

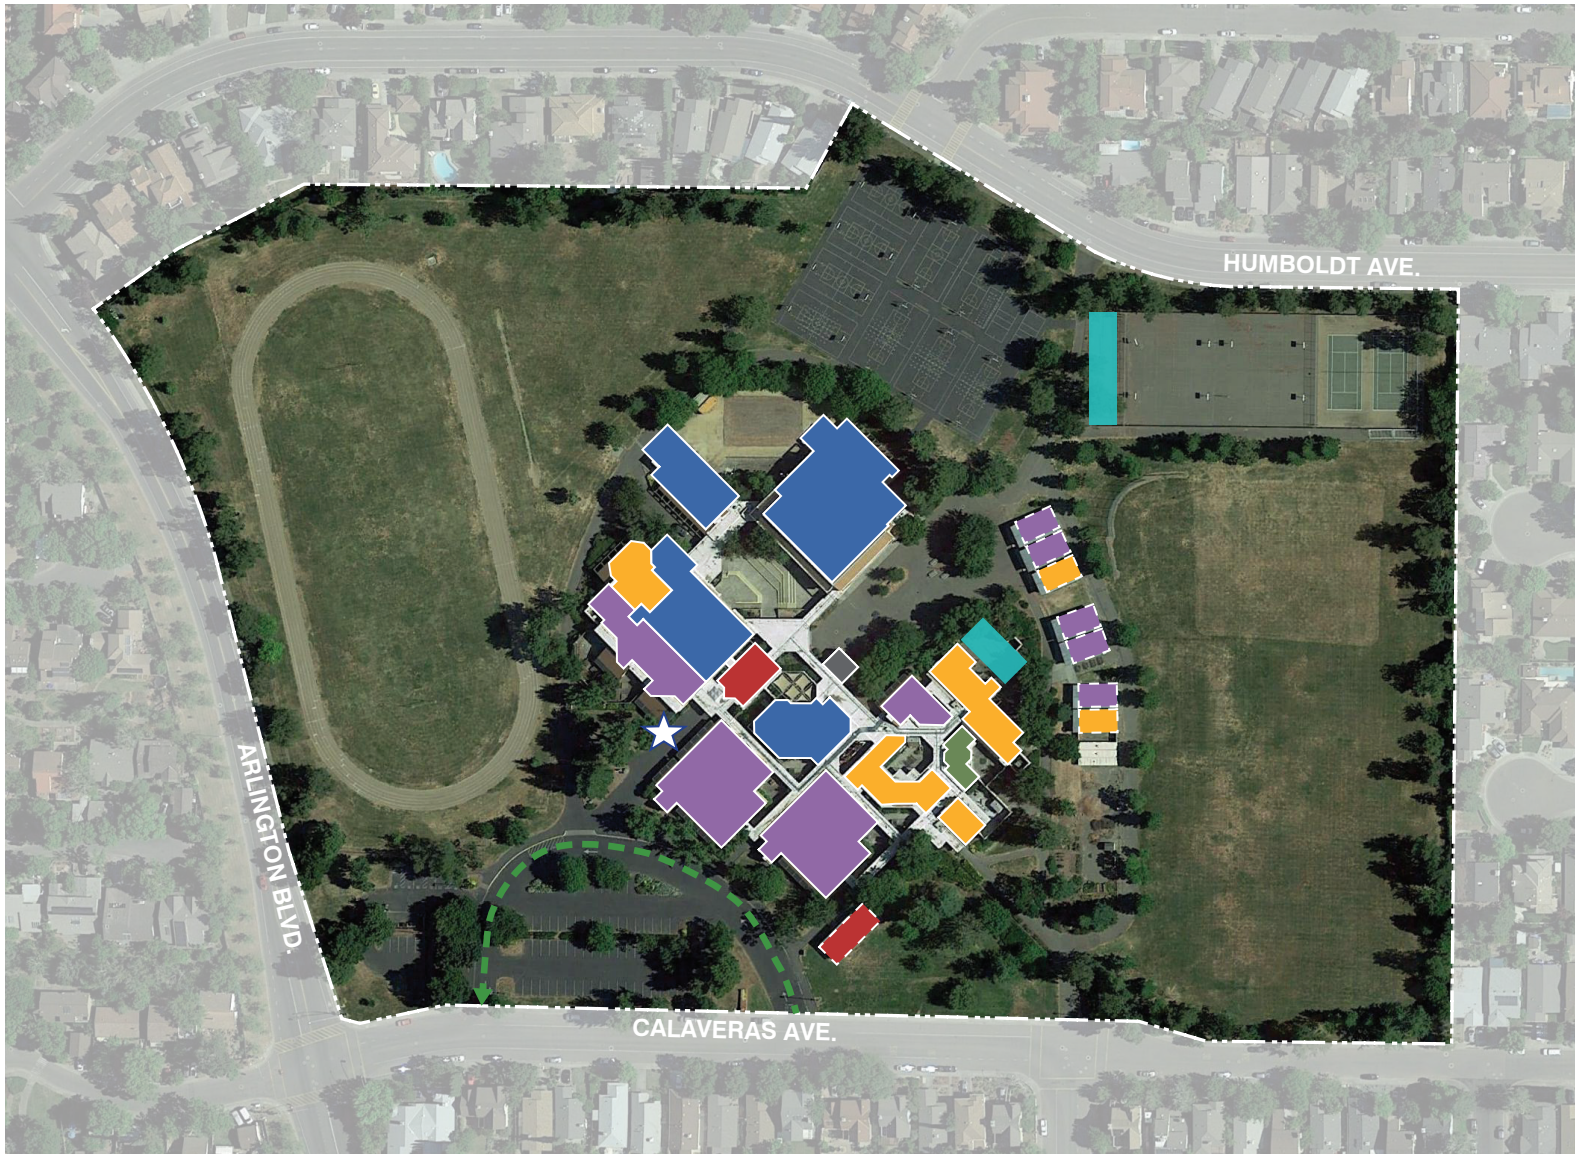
Classrooms, CR
 ELA - English Language Arts, FLA - Foreign Language
 INC - Inclusion, MA - Math, MI - Math Intervention
 R - Reading Intervention, SS - Social Studies
 TA - Teaching Assistant

Electives / Labs
 CS - Computer Science, HE - Home Economics
 P - Practice, SCI - Science, TECH - Technology
 WD - Woodshop, WT - Weight Room

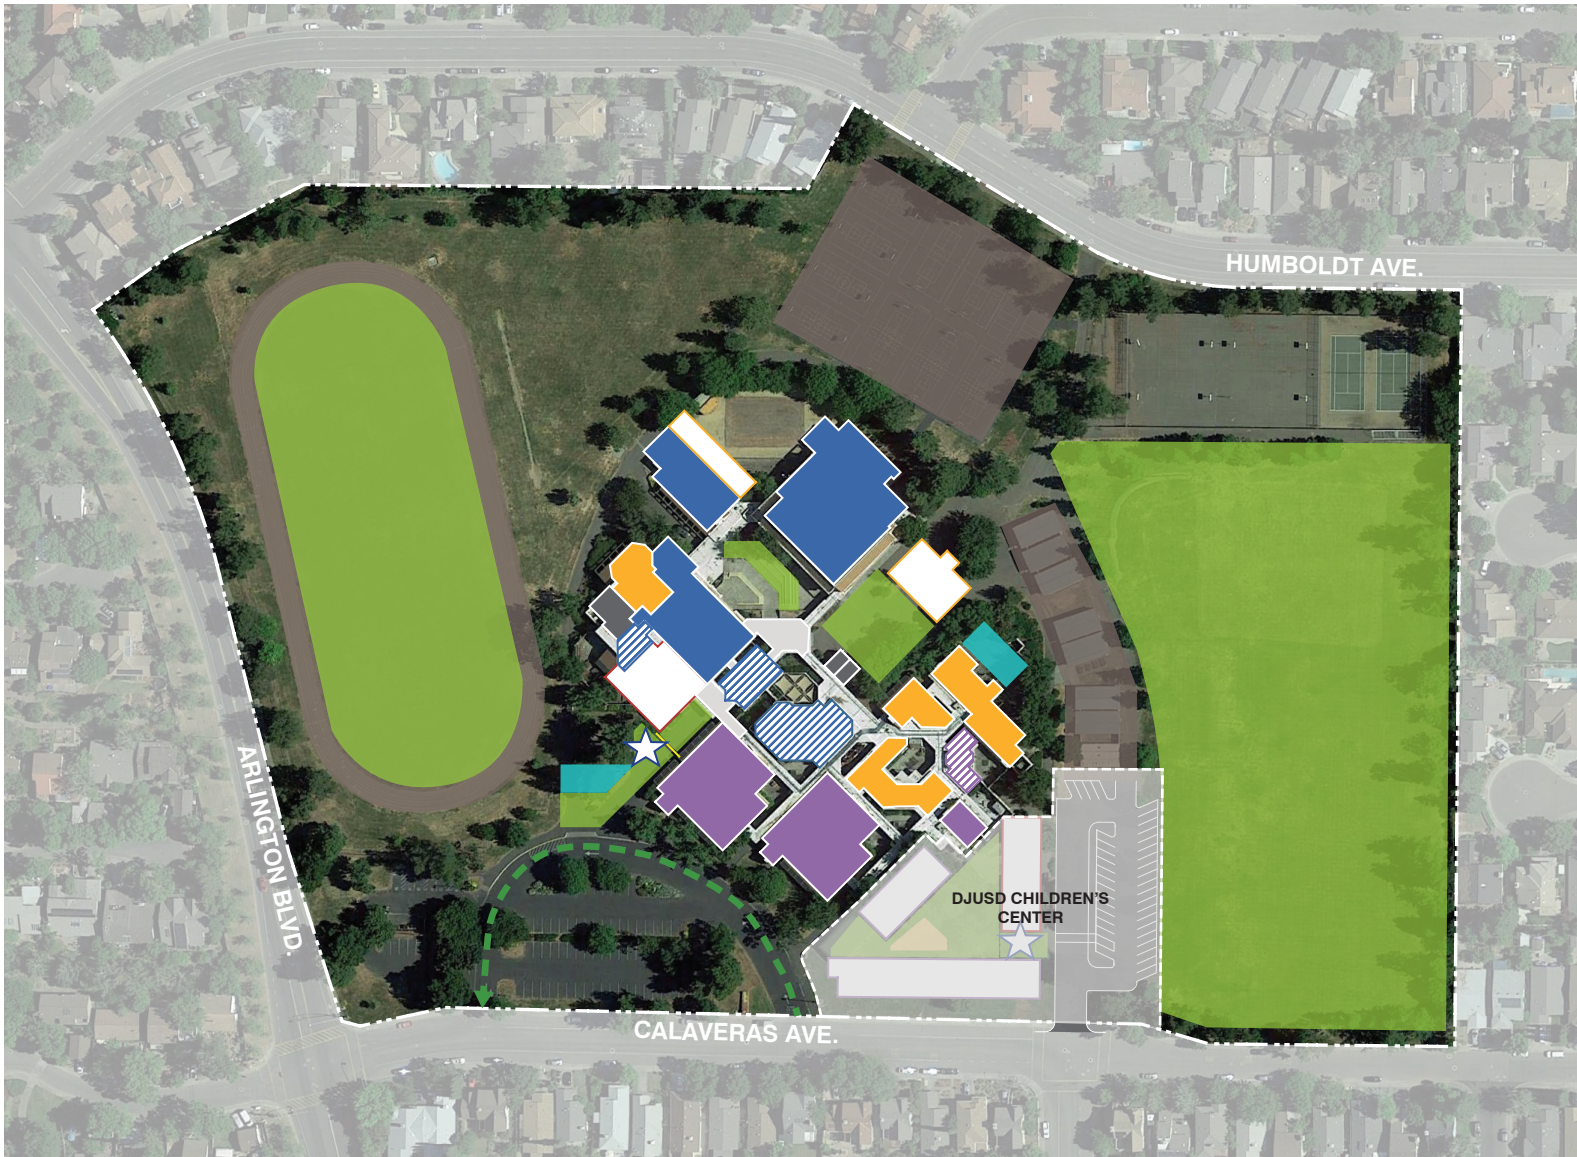
**EXISTING CAMPUS PLAN
 EMERSON JUNIOR HIGH - ENLARGED**

Classrooms, CR
 ELA - English Language Arts, FLA - Foreign Language
 INC - Inclusion, MA - Math, MI - Math Intervention
 R - Reading Intervention, SS - Social Studies
 TA - Teaching Assistant

Electives / Labs
 CS - Computer Science, ENG - Engineering
 HE - Home Economics, MKR - Maker
 P - Practice, SCI - Science, TECH - Technology
 WD - Woodshop, WT - Weight Room

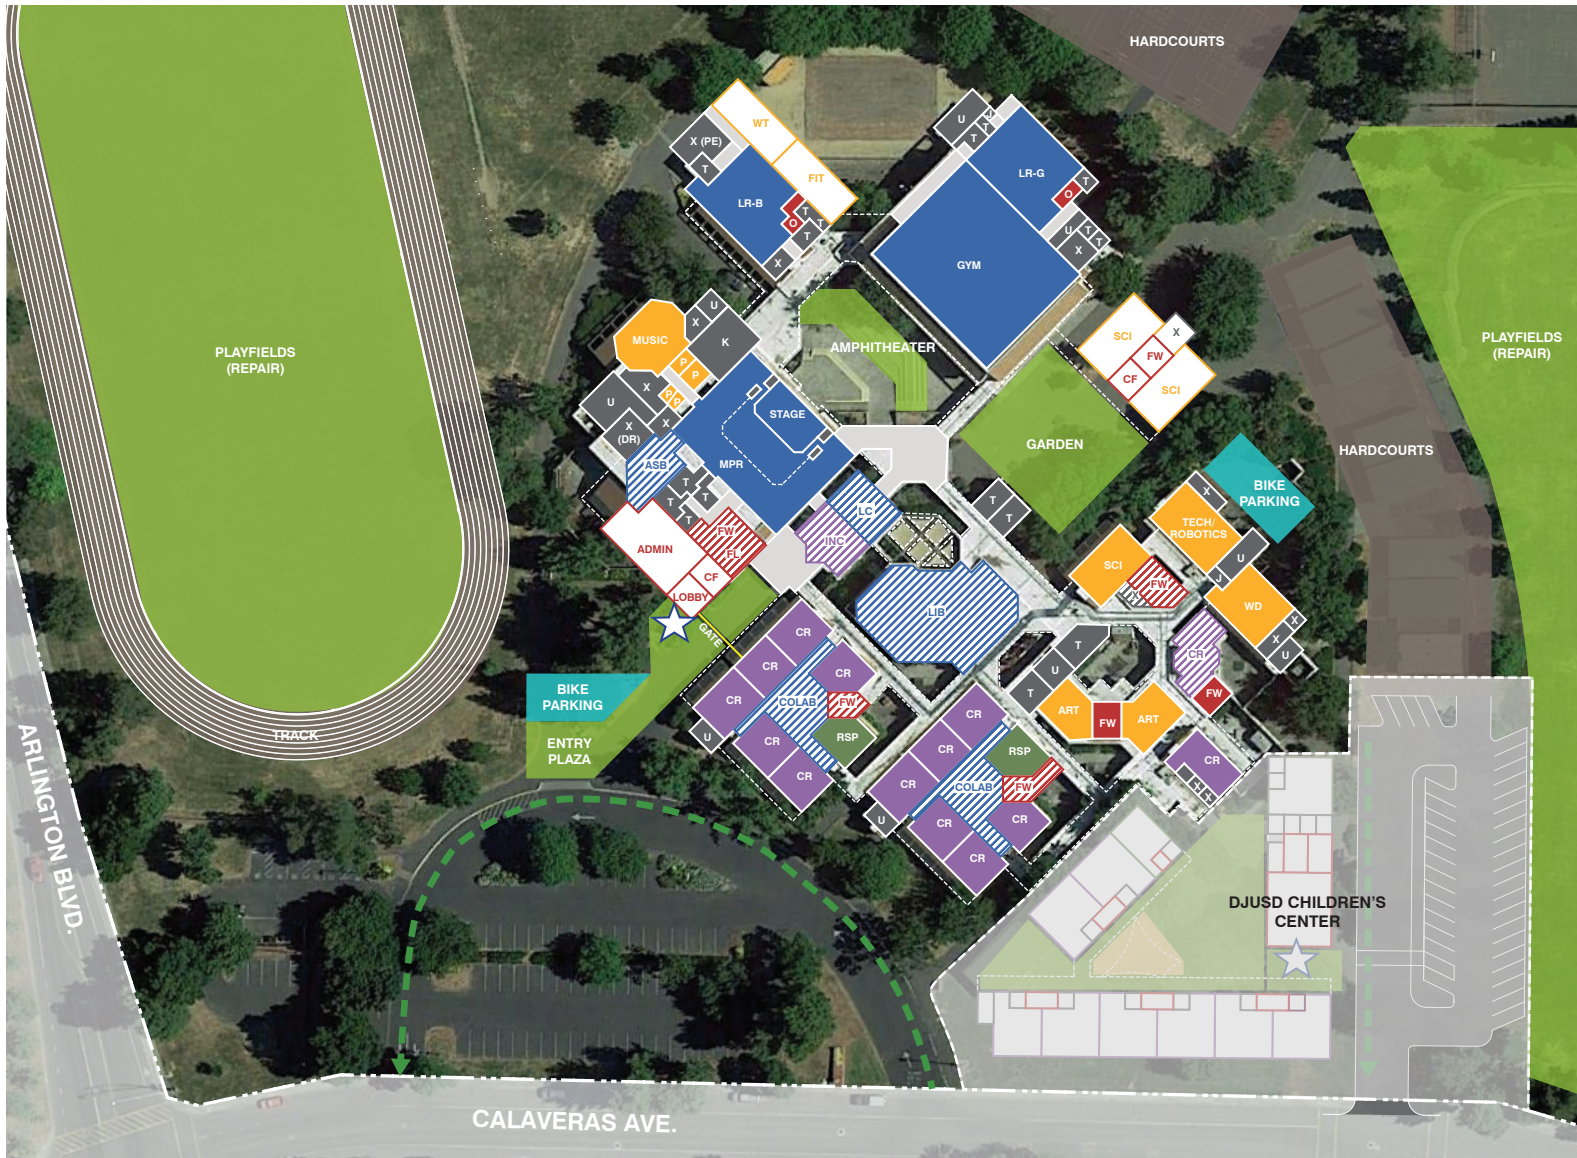
Classrooms, CR
 ELA - English Language Arts, FLA - Foreign Language
 INC - Inclusion, MA - Math, MI - Math Intervention
 R - Reading Intervention, SS - Social Studies
 TA - Teaching Assistant

Electives / Labs
 CS - Computer Science, ENG - Engineering
 HE - Home Economics, MKR - Maker
 P - Practice, SCI - Science, TECH - Technology
 WD - Woodshop, WT - Weight Room
