SITE DATA

315 W 14th Street, Davis | www.dshs.djUSD.net

FACILITY CONDITION ASSESSMENT DAVIS SENIOR HIGH

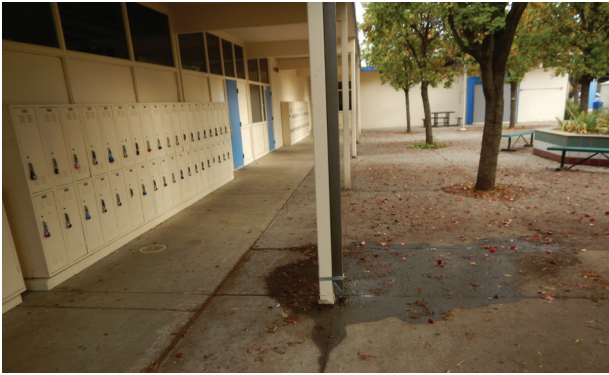
Covered Walkway

- Covered walkway structures are in good condition.

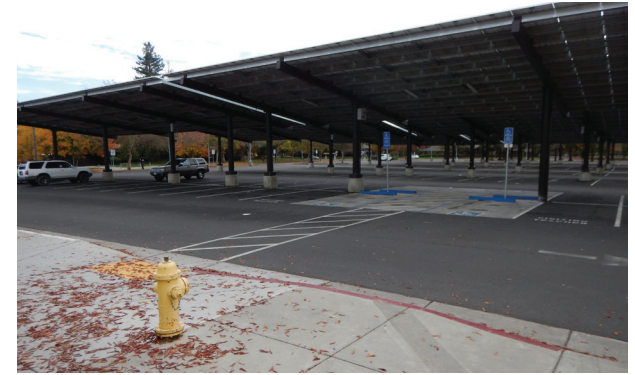
Parking

- No issues observed, capacity seems to be enough to accommodate campus student load.
- There is drop off area in the student parking lot area, although there are no 9 graders on campus.

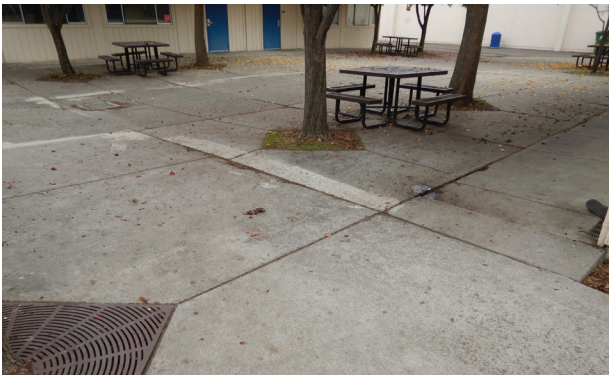
Concrete Paving

- In general, the concrete paving is in fair condition. Minor cracks observed, some floor utility box lids need replacement. Several areas have uneven surface concrete joints with the AC paving / pavers which need to be repaired to mitigate tripping hazards.
- The sloped pavement at access plaza area from W 14th Street to Administration building seems a little steep, recommend verify slope for accessibility compliance.

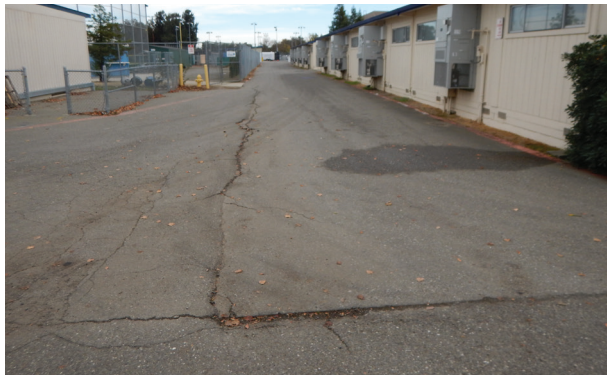
Asphalt Paving

- The AC paving in the staff parking next to administration area, the access path to campus from W 14th Street, area in front of portables on north side and in the area between the gymnasiums need a heavy slurry coat.
- The area behind the auto shop needs an overlay due to heavy cracking and excessive patching in the area.
- The areas adjacent to the Agricultural building need pavement replacement.

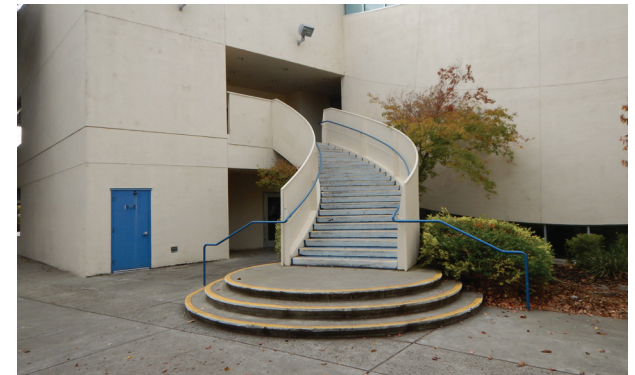
Ramps / Stairs

- In general, all ramps and stairs are in fair condition.
- The stairs in main entry plaza area from W 14th Street to Administration building need to have handrails reconfigured for accessibility.
- Handrail in front of language classrooms is missing a portion and extension rails on ramp need to be adjusted to meet accessibility.

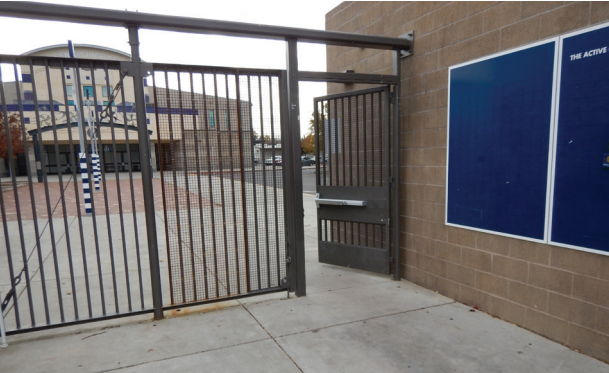
Fencing / Gates

- Gates at agricultural building enclosed area need to be upgraded for accessibility. There is no fencing and signage separating the soccer field and the park area.

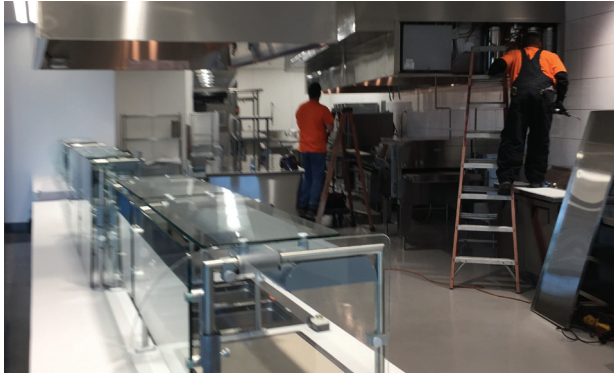
Food Service @ New Student Center

- Not accessed, area under construction with new student center building.

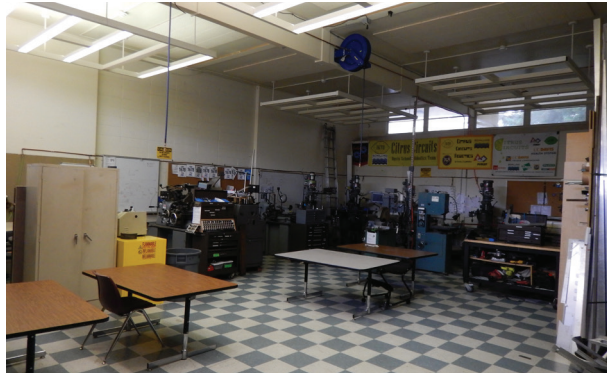
Metal Shop

- New HVAC systems needed in the Barn, Robotics, CTE, and Metal Shops.

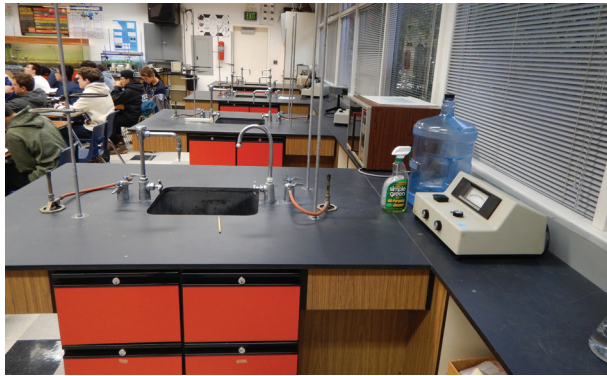
Science Lab

- Bathroom upgrades needed.
- Science building needs to be re-piped.

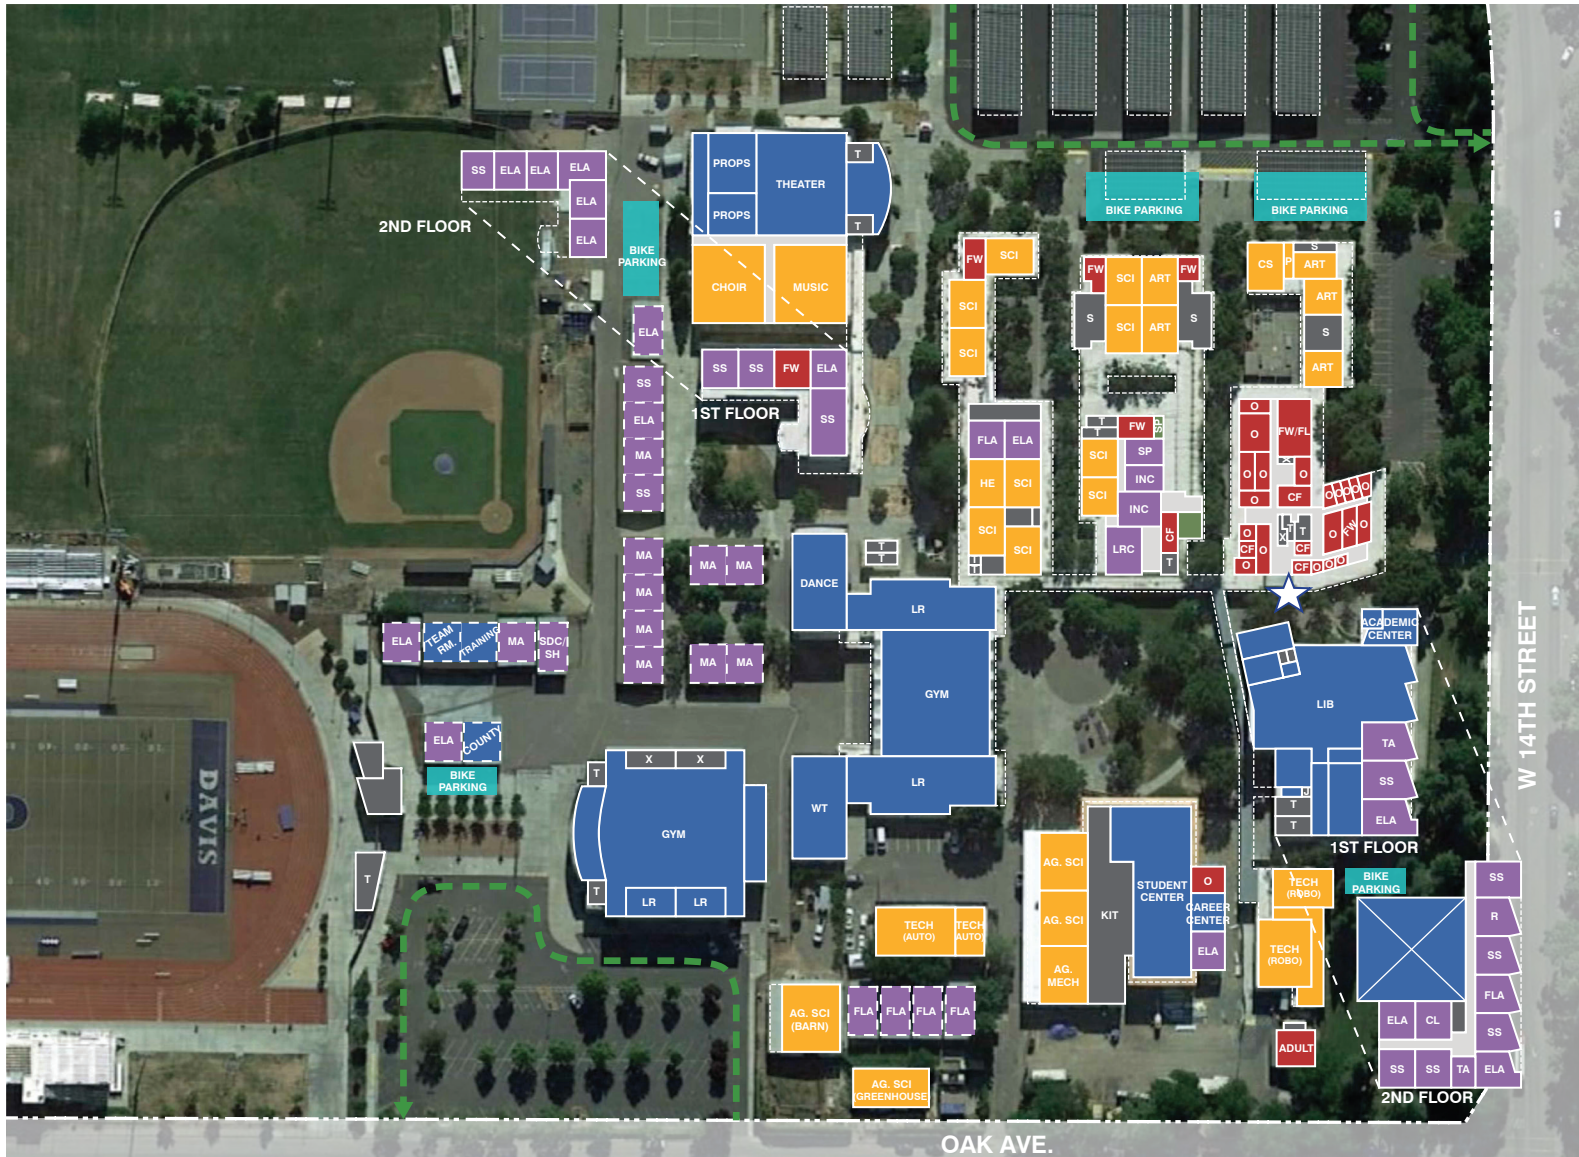
**EXISTING CAMPUS PLAN
 DAVIS SENIOR HIGH - OVERALL**

Classrooms, CR
 ELA - English Language Arts, FLA - Foreign Language
 INC - Inclusion, MA - Math, MI - Math Intervention
 R - Reading Intervention, SS - Social Studies
 TA - Teaching Assistant

Electives / Labs
 CS - Computer Science, HE - Home Economics
 P - Practice, SCI - Science, TECH - Technology
 WD - Woodshop, WT - Weight Room

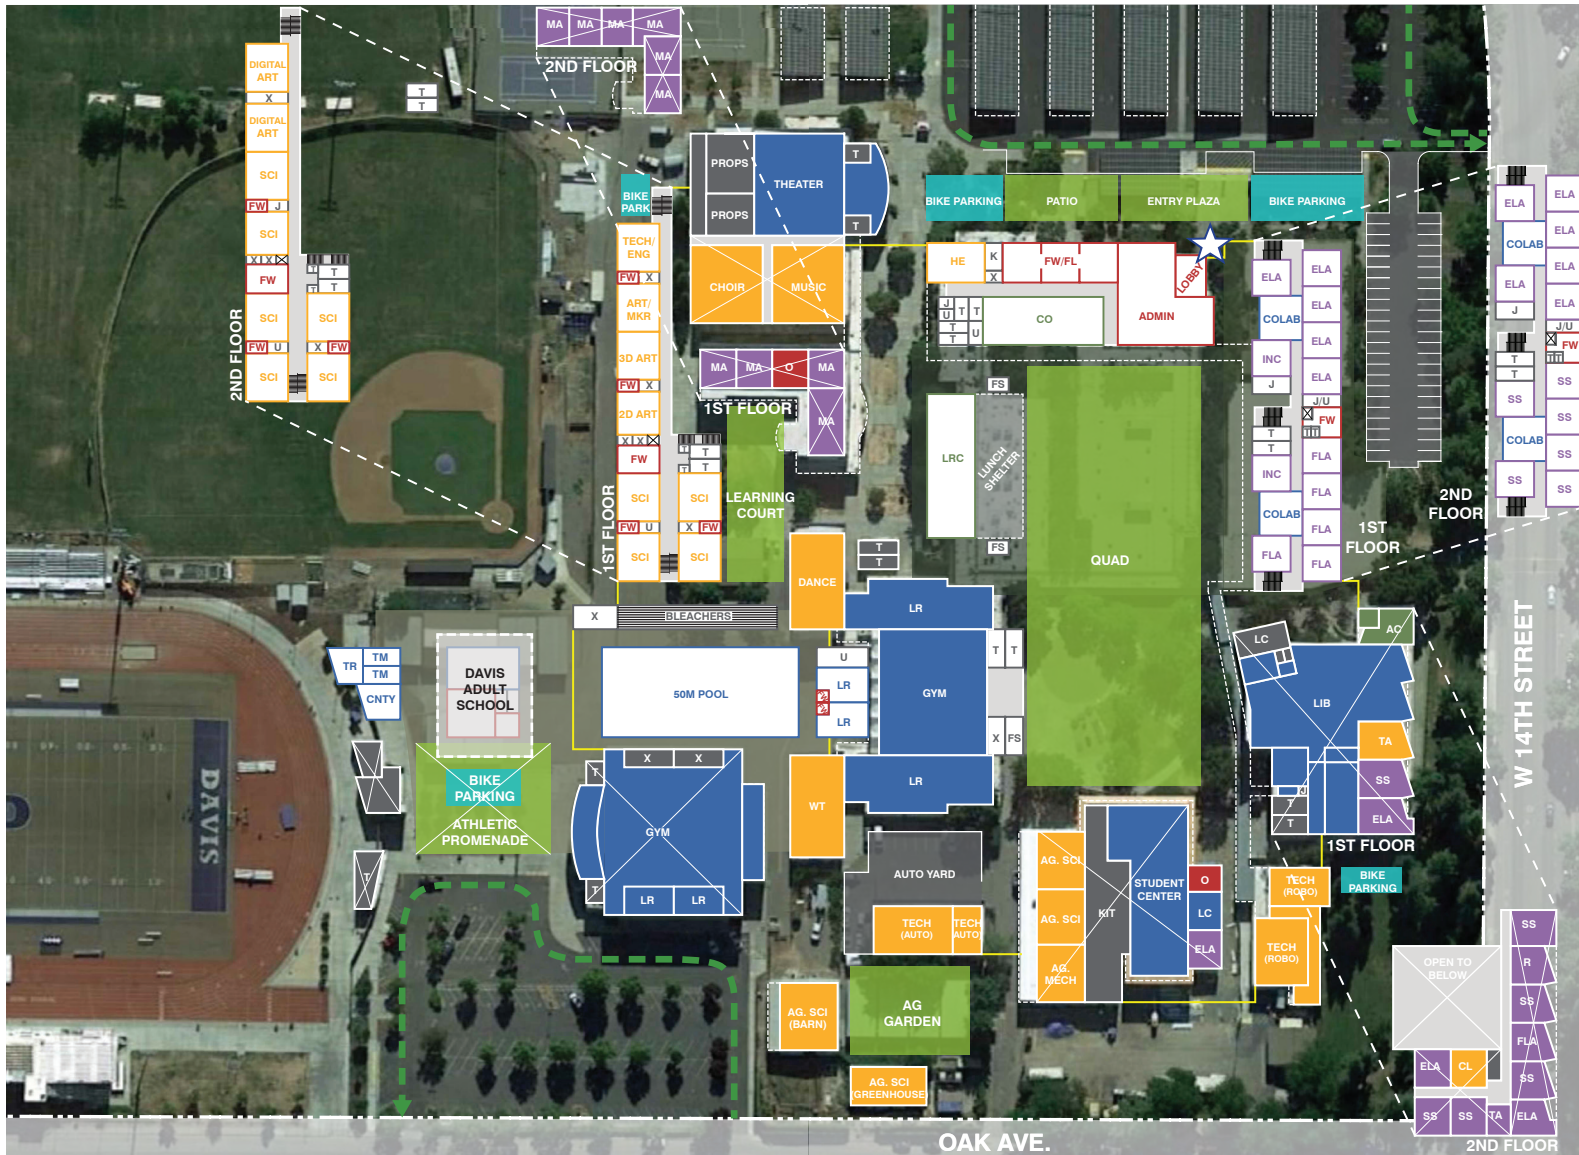
**PROPOSED CAMPUS MASTER PLAN
 DAVIS SENIOR HIGH - OVERALL**

Classrooms, CR
 ELA - English Language Arts, FLA - Foreign Language
 INC - Inclusion, MA - Math, MI - Math Intervention
 R - Reading Intervention, SS - Social Studies
 TA - Teaching Assistant

Electives / Labs
 CS - Computer Science, ENG - Engineering
 HE - Home Economics, MKR - Maker
 P - Practice, SCI - Science, TECH - Technology
 WD - Woodshop, WT - Weight Room
