FACILITY CONDITION ASSESSMENT DA VINCI CHARTER ACADEMY JUNIOR HIGH

**EXISTING CAMPUS PLAN
 DA VINCI CHARTER ACADEMY JUNIOR HIGH**

FACILITY CONDITION ASSESSMENT DA VINCI CHARTER HIGH / DJUSD CHILDREN'S CENTER

**EXISTING CAMPUS PLAN
 DA VINCI CHARTER HIGH**

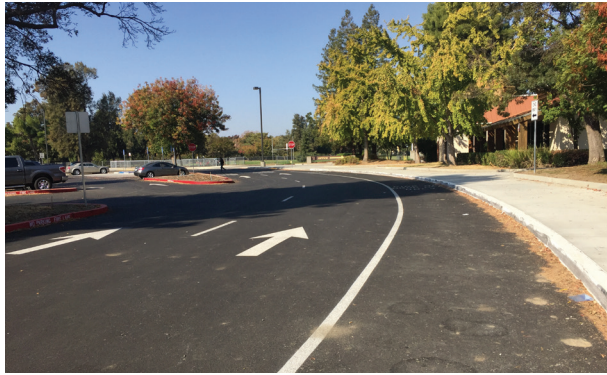
Drop-Off Lane

- Parking is sufficient with a dedicated drop-off lane separate from parking drive aisles.

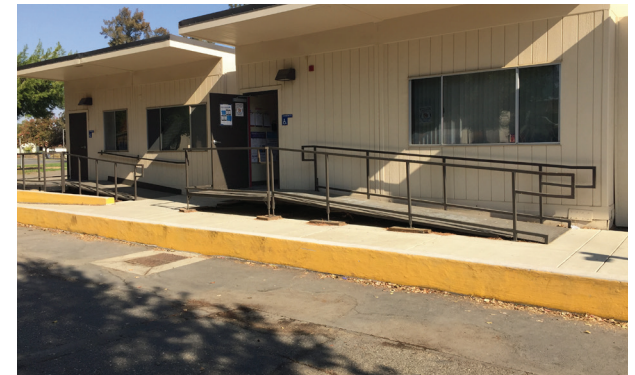
Ramps / Stairs

- The metal ramp at the Administration building is in good condition.
- The metal ramp at the Science portable is in fair condition.

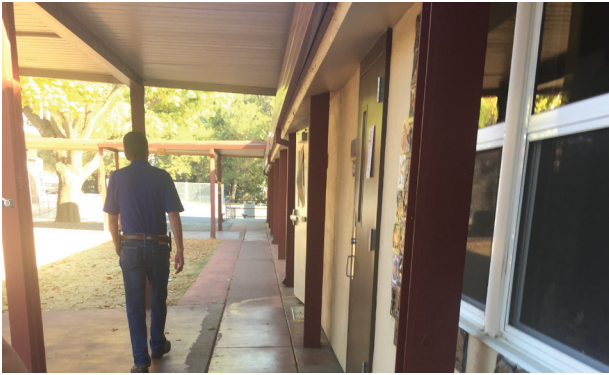
Covered Walkway

- Walkway awnings are in good condition.

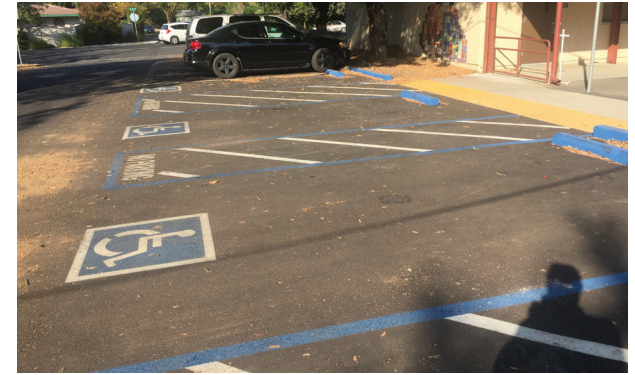
- Parking is minimal and does not accommodate the demand.

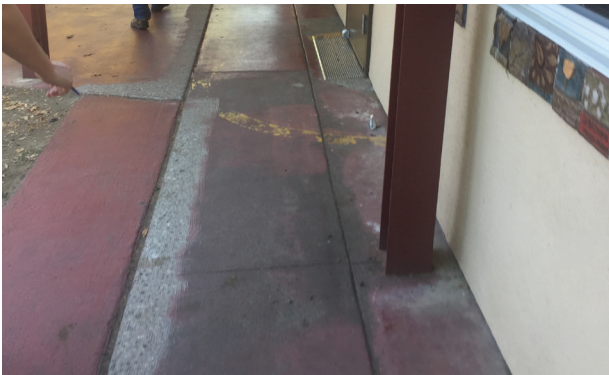
Concrete Paving

- Concrete paving on campus is in fair to good condition. Areas where the paving has been ground down is apparent, especially where concrete was originally painted red at D wing.
- Some areas have vertical offsets in adjacent surfaces that pose a tripping hazard.

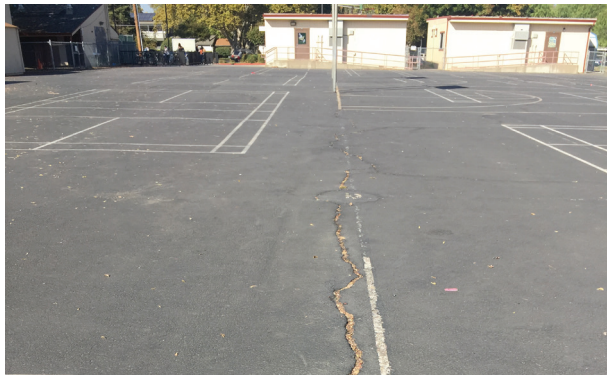
Hardcourts

- AC paving in the parking lot was resurfaced in 2017 and is in good condition.
- AC paving at the hardcourts has large cracks and needs to be resurfaced and striped.

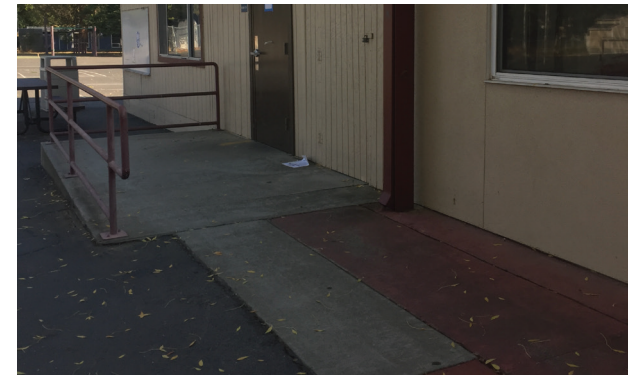
Ramps / Stairs

- Uneven transitions to AC at bottom landings. Wide gaps.
- No issues reported.

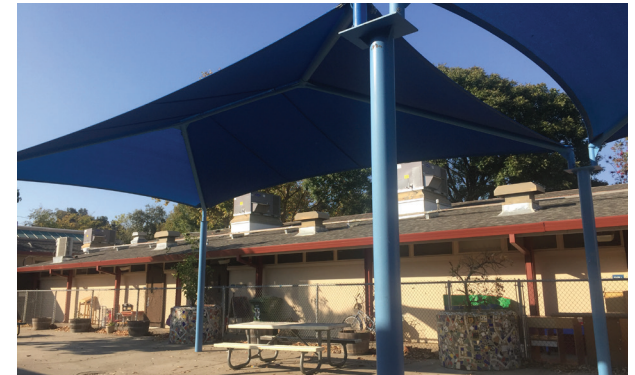
Shade Structure

- Cloth shade structure is in good condition.

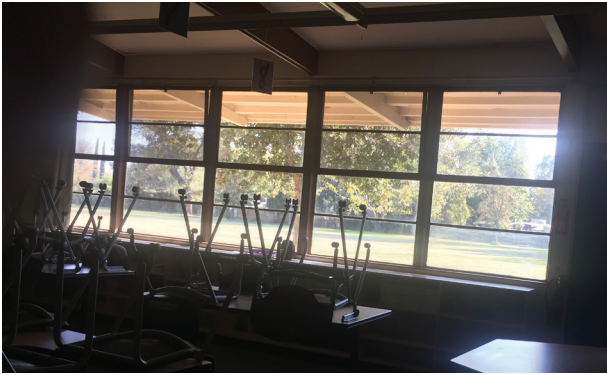
- Windows are single-pane with vertical blinds.
- MPR has a linear skylight that runs the length of the roof and has operable slats for shade.
- Buildings would benefit from insulated, dual-pane windows.

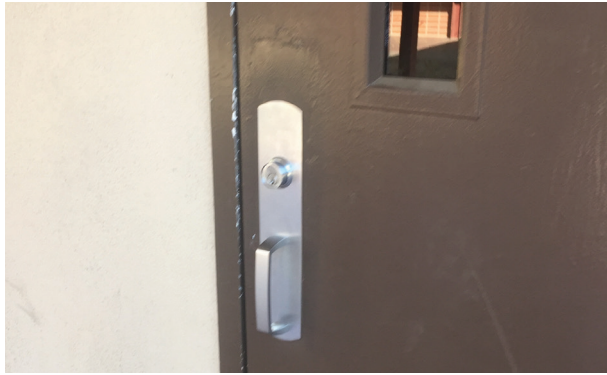
Exterior Door Hardware

- All doors, frames, and hardware are in good condition, despite minor paint chips due to normal wear and tear.

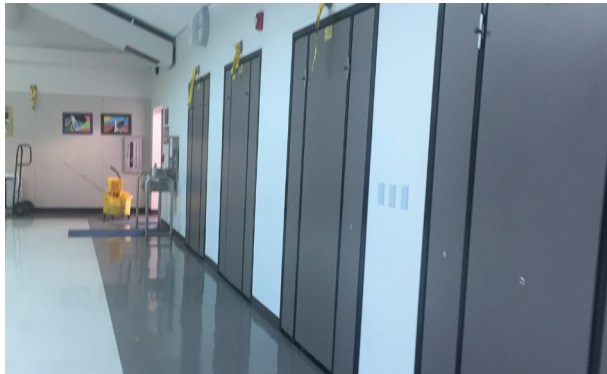
Dining Area

- The kitchen at the MPR is in good condition.
- Indoor dining is accommodated with tables that fold out from the wall. These are in good condition.
- Students also eat outdoors in various locations. The site would like a central, outdoor quad for students.

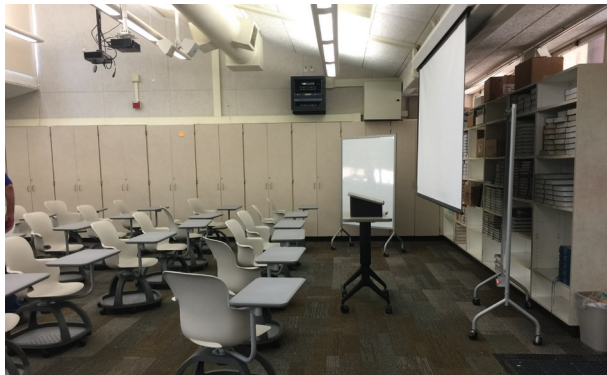
- Room 9 is known as the Presentation Room or Library. This room has a variety of flexible furniture including soft seating options.
- A tech service area is available in the Presentation Room that assists students with their campus-provided devices.
